Navajo Abandoned Uranium Mine

Site Screen Report

Mine Name: **Daylight**Mine ID: **393**

April 2012

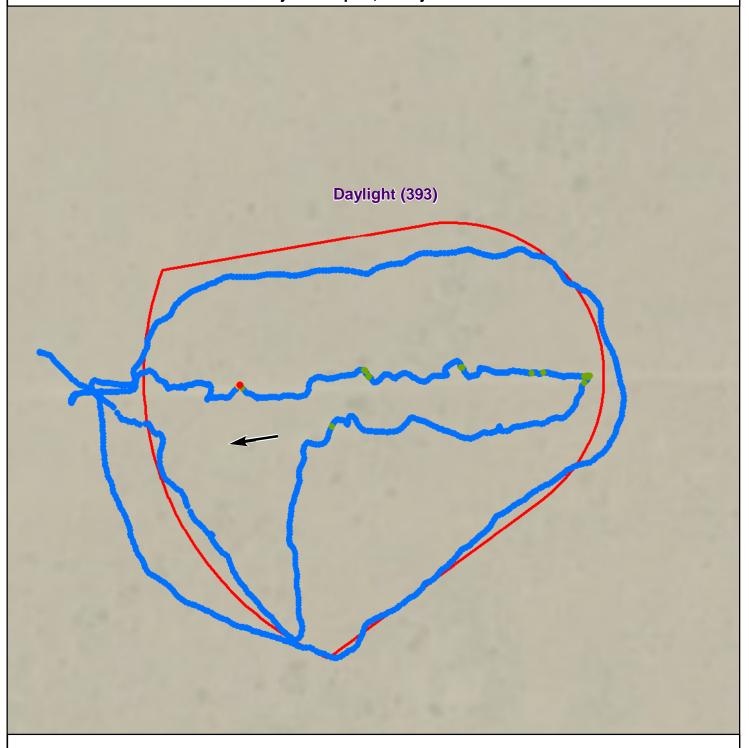
Figure 2 - Gamma Radiation Measurements Daylight (393) Oljato Chapter, Navajo Nation

A total of 1,434 gamma radiation measurements were collected from the mine site, ranging from 4,955 cpm to 113,360 cpm. The measurements are represented in Figures 1 and 2.
